ROCK SLOPE STABILITY ANALYSIS OF QUARRY SITES AT WEST MALVERN, UK.

ABSTRACT: This paper analyzes the scan line survey data of the geological discontinuities collected from three quarry sites of West Malvern in Malvern Hills, UK, which remain one of the major resources of geological materials for building stones and aggregates in the area. The kinematic analysis of the discontinuity data of the quarry sites was performed by using the DIPS software, which showed the likelihood of wedge, plane and toppling failures of the slopes. However, no failure is likely even for the steepest slope faces if planned to cut in the dip direction range of 30° to 70° and 130° to 230°.

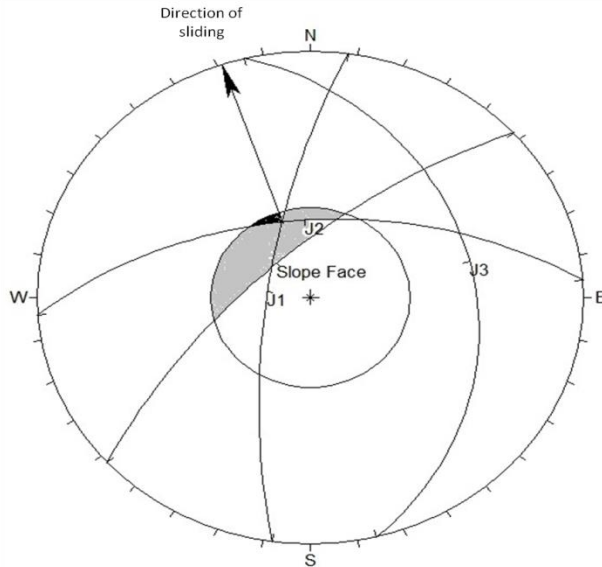
Figure 4 showing description of wedge failure.

CASE I: Considering slope face orientation of 69/318 and stereographic projection of mean discontinuity planes drawn through DIPS showed a phenomena of kinematic instability (Figure-4). Sliding envelope shown by shaded area represented the conditions of Markland's wedge failure (Markland, 1972) i.e. plunge of line of intersection

of two joint planes must be less than the slope face angle and greater than friction angle. In the current situation the plunge of line of intersection of J_1 and J_2 measured was 54° , greater than the 40° (the friction angle) and less than 69° (plunge of slope face). Therefore, potential of sliding movement of block shown by dark shaded area existed at quarry site having a plunge of slope face greater than 60° and dip direction between 315° and 355° . In this particular case the wedge block was likely moving in the direction of $N19^\circ W$ along the line of intersection (Figure-4).

Orientation of quarry slope	Dip of Slope face	Failure/Stable	Mode of Failure	Recommended safe quarry slope
000° to 020°	60° to 90°	Failure	Plane	$\psi_f < 50^\circ$
030° to 070°	Any	Stable	-	-
080° to 100°	80° to 90°	Failure	Toppling	$\psi_f < 45^\circ$
130° to 230°	75° to 90°	Stable	-	-
260° to 275°	75° to 90°	Failure	Plane	$\psi_f < 65^\circ$
310° to 350°	60° to 90°	Failure	Wedge	$\psi_f < 50^\circ$

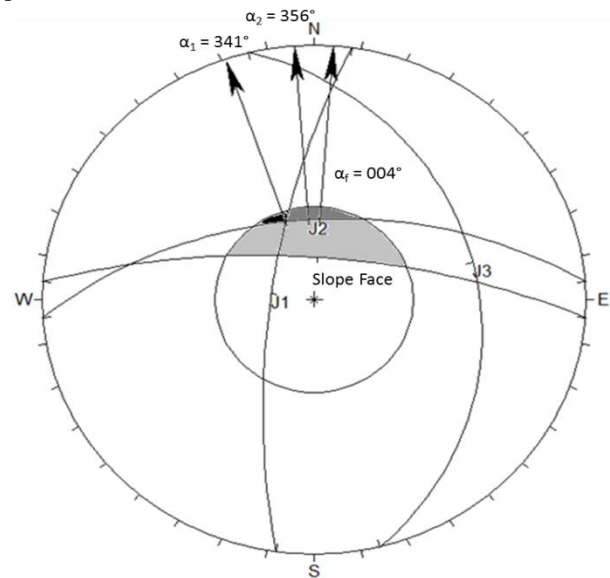
Figure 5 showing description of combination of plane and wedge failure

CASE II: Kinematic analysis was performed for another possible orientation of slope face of 71/004. In this case, there was likelihood of plane and wedge failures (Figure-5). Another important aspect was the fulfillment of (Hocking's refinement 1976) which was introduced to differentiate between the sliding of a wedge along the line of intersection or along one of the planes forming the base of the wedge. According to Hocking, if the dip direction of either of plane fell between the dip direction of the slope face, the trend of the line of intersection, sliding will occur on that plane instead of along the line of intersection. Therefore, in this case, the wedge block moved along J_2 instead of line of intersection of J_1 and J_2 . Figure-5 clearly fulfills the Hocking's refinement where:

Moreover, J_2 satisfied the conditions of plane failure as described by (Hoek and Bray, 1981). The dip of sliding plane should be less than the dip of slope face and greater than friction angle, and the trend of sliding plane should be within 20° of the slope face trend. In this

particular case, dip of J_2 was 55° which was less than that of slope face that was inclined at 69° and greater than the friction circle i.e. 40° . Both wedge block and sliding mass by plane failure are shown by relatively dark shaded area (Figure-5).

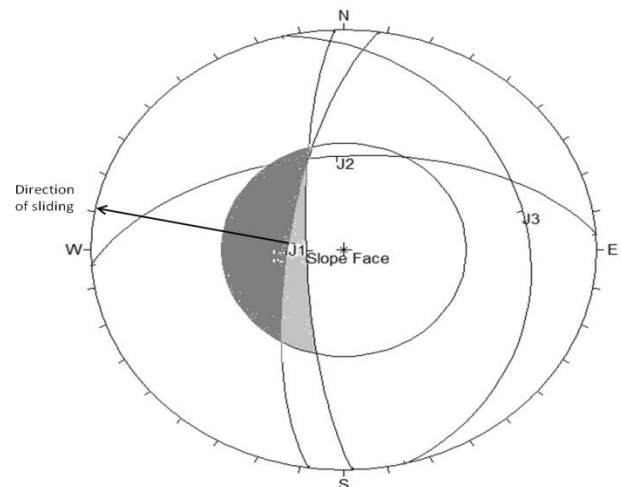
Figure 6 showing description of plane failure.

CASE III: Case III was concerned with the stability of slopes having face orientation of 78/268. In this case the possibility of plane failure was apparent (Figure-6). The angle difference between the dip direction of J_1 and the slope face was only 10° . Sliding of the mass shown by the shaded area was along the joint plane J_1 . Along with other conditions, role of the release surfaces in plane failure of the slopes was critical. Release surfaces may exist if some other discontinuities intersect the sliding plane.

If other discontinuities intersected the sliding plane at two points in the sliding envelope bounded by the region between slope face and sliding plane (shown by shaded area), then plane failure was evident. In this case J_2 intersected J_1 only at one point in the sliding envelope, which suggested a relatively remote chance of plane failure of the slope. However, other factors such as strength of rock mass and ground water conditions should be considered to check the factor of safety.

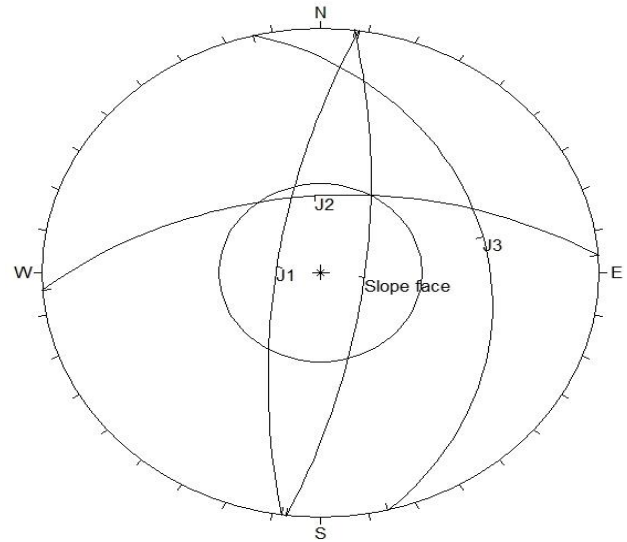
Figure 7 showing description of Toppling Failure.

CASE IV: If the slope face had a dip angle in the range of 80° to 90° and dip direction of 80° to 100° then there were fair chances of toppling failure (Figure-7). This was due to the reason that great circle of J_1 had a steeper angle of 72° which dipped into the slope face.
