ROCK SLOPE STABILITY ANALYSIS OF QUARRY SITES AT WEST MALVERN, UK.

ABSTRACT: This paper analyzes the scan line survey data of the geological discontinuities collected from three quarry sites of West Malvern in Malvern Hills, UK, which remain one of the major resources of geological materials for building stones and aggregates in the area. The kinematic analysis of the discontinuity data of the quarry sites was performed by using the DIPS software, which showed the likelihood of wedge, plane and toppling failures of the slopes. However, no failure is likely even for the steepest slope faces if planned to cut in the dip direction range of 30° to 70° and 130° to 230°.

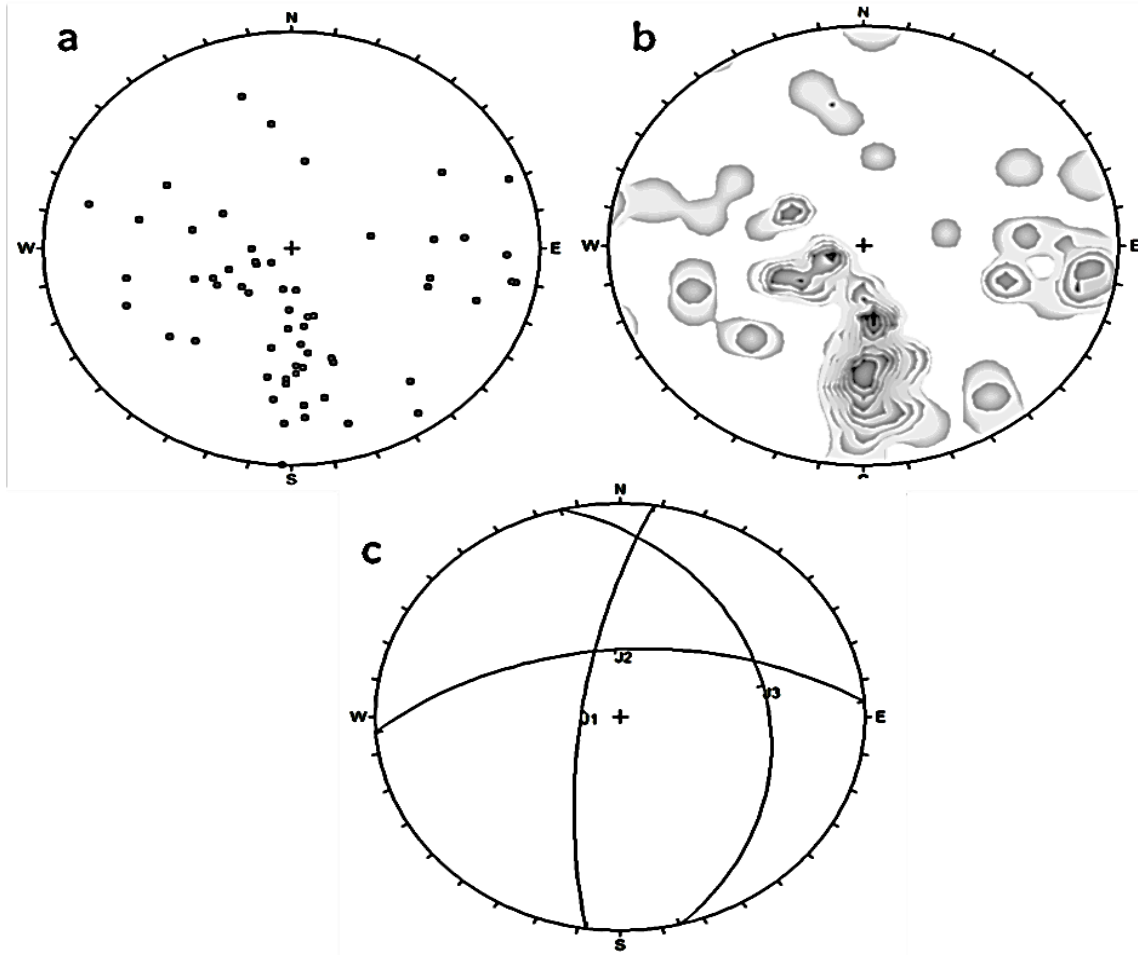
Figure 2 showing (a) Pole plot, (b) Contour plot, and (c) Great circles of dominant discontinuities.

The discontinuities data was collected by scan line survey along the exposed cut faces of the old quarries. Dip and dip directions of geological discontinuities were measured and analyzed through stereographic projections using DIPS software. The data set consisting of 62 discontinuities was then used for pole plotting (Figure 2a), which was subsequently utilized for contour plotting (Figure 2b). Plotting of the data identified three major pole concentrations. The pole concentrations helped in identifying the representative great circles of the discontinuities (Figure 2c). A friction

Possible slope face orientations: The pole concentrations of the discontinuities data showed that the quarry sites had three major discontinuity planes (J₁, J₂ and J₃); two of them were steeper while the other one was relatively flat (Table 2). Although all three major discontinuity planes were making wedges but two of them were lying outside the friction circle whereas the wedge formed by the intersection of J₁ and J₂, was inside the friction circle (Figure-3). Keeping in view the likely future orientations of the slope faces at the quarry sites (Table-3), different slope failure cases are discussed.
